# WATERSHED WEEK IN REVIEW

## Llano River Floods at Near Record Levels

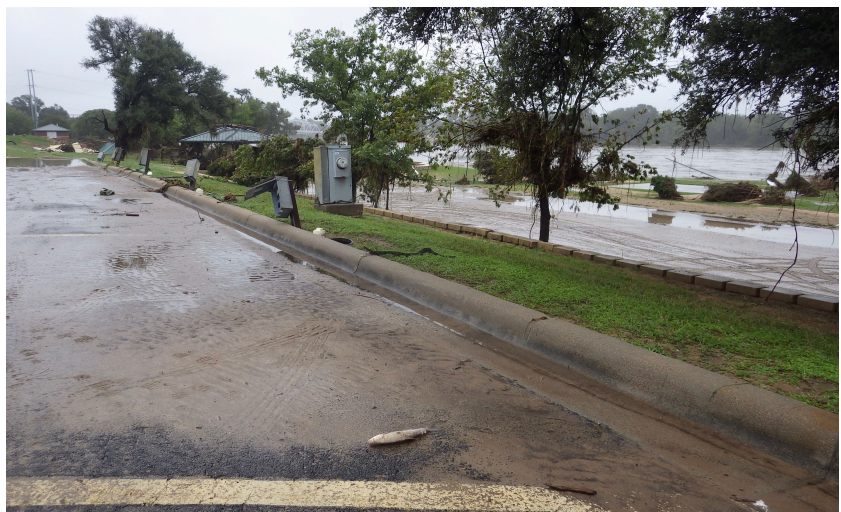
*Tuesday's floodwaters brought extensive damage to Badu Park in Llano.*

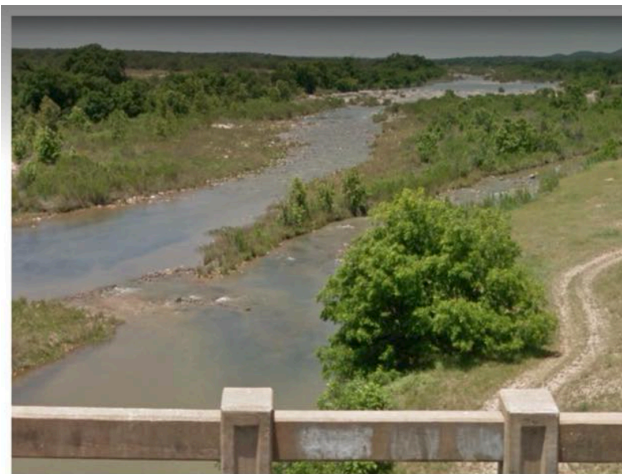
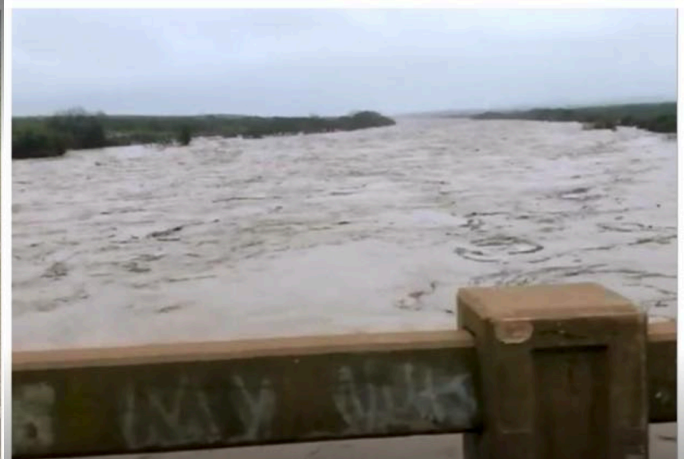
*Llano River near Mason at US 87 Bridge. Left: low flow, undated. Right October 16, 2018  
Source : Facebook Page, The Fish Camp*

followed by a second peak at 12:40pm of 32 ft (175,000 cfs). The 33 ft peak exceeded the 2000 flood peak of 32 ft and was below the 1980 flood peak of 37 ft. The record flood peak for the Mason gage is 46 ft in June of 1935, which also destroyed the bridge at this location.

Rainfall above the Mason gage near the US 87 bridge resulted in an initial peak at 5:25am of 33 ft (182,000 cfs),

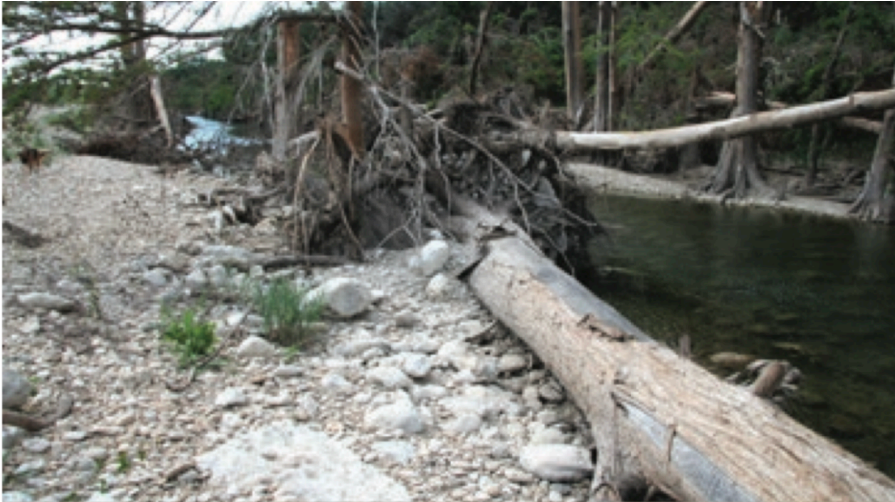
Ironically, one of the benefits of the flood was the addition of thousands of logs and downed trees to the banks and floodplain. Logs such as this will form new stronger bank as new soil material is deposited behind the log.

*Paradoxically, the loss of thousands of cypress and other trees can actually help the recovery and future stability of the river. For decades, river scientists have known that large logs and downed trees play an essential role in river stability. The woods helps dissipate energy and slow the water. The logs function as large strong retaining walls to help build and support new banks. As the wood is eventually buried by future floods, it reinforces the banks and floodplain, similar to rebar in a*
