WATERSHED WEEK IN REVIEW

Two Photos and 40 Years of Observation of the South Llano River

By Scott Richardson

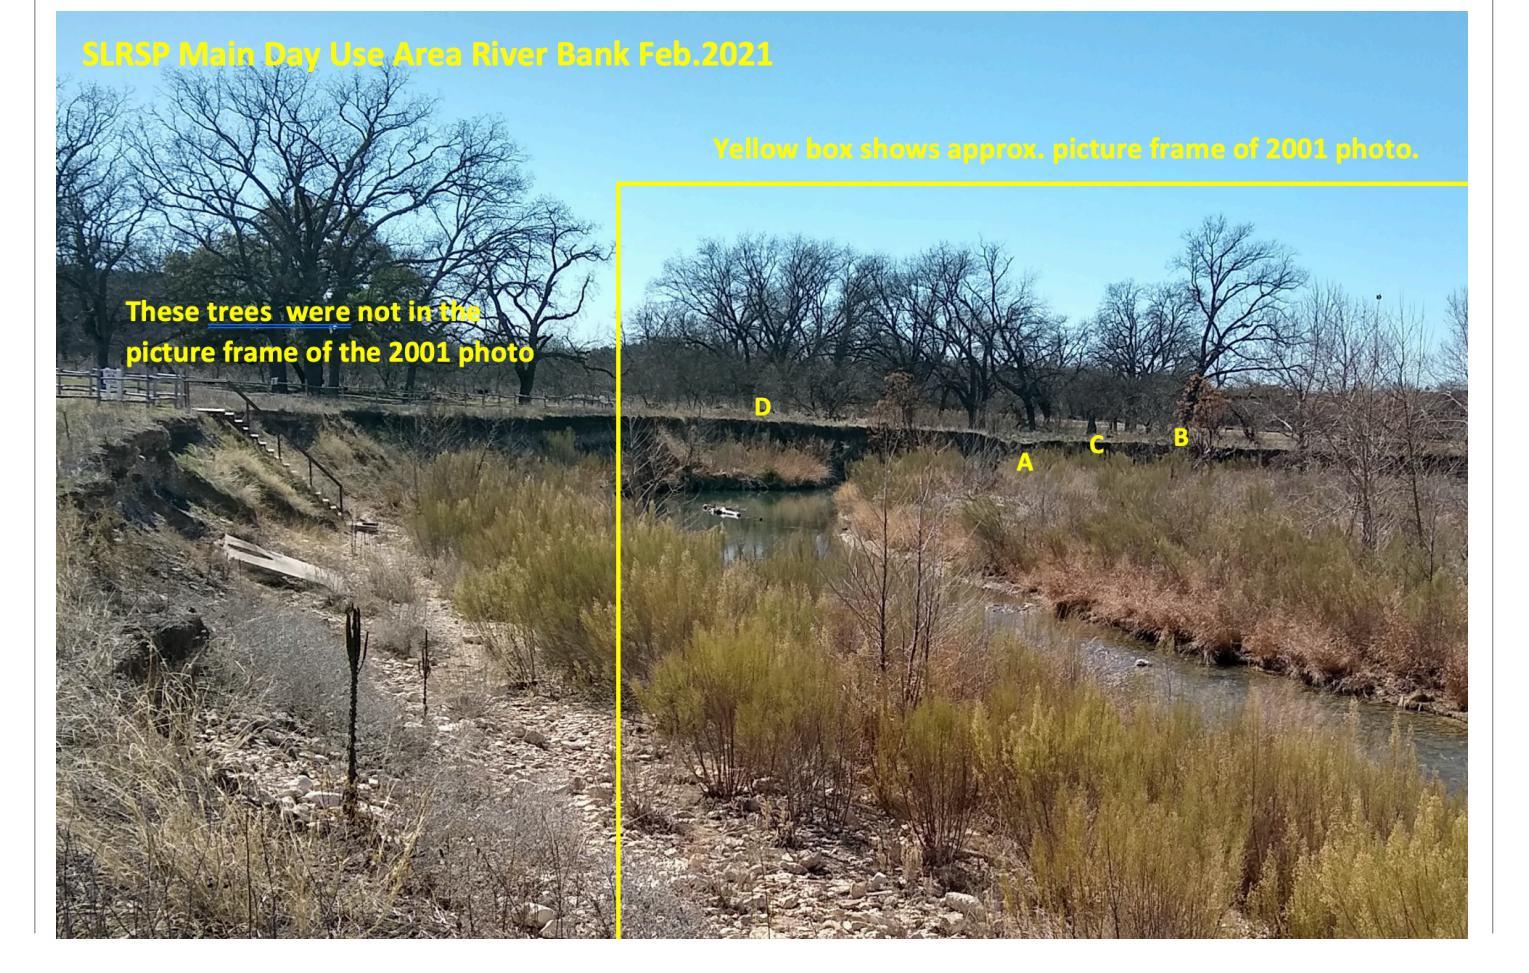
The two labeled photos were taken from approximately the same point on the South Llano River at the Main Day Use Area in the South Llano River State Park, but nearly 20 years apart. The first was taken in April, 2001 and the second in February, 2021. From the photos one can see changes that have occurred during those 20 years in both the morphology (the shape of a river channel), the vegetation of the riparian area, and the flow of the river. These changes tell a story or illustrate much of what I've observed

First, let's compare the two photos and see what the comparison shows us. The capital letters "A-D" on both photos are marking the same natural reference points that can be found in both photos. For example, if you look closely at the branching of the tree in both photos, labeled "B", you will see that it's the same, indicating that this reference point is the same in both photos. The tree labeled "C" in the 2001 photo is the same as the large stump labeled "C" in the 2021 photo. If you look closer you will find additional trees that are in both photos. The "D" is between two of these trees. The point labeled "A" in both photos is not a tree but a depression along the top edge of the cut bank. This depression is actually an outlet for a drainage coming from the south. These labeled points help us orient the two photos for comparison.

By comparing the two photos one sees how erosion and deposition change the morphology of a river over time, specifically in a growing meander or curve in the channel. On the right side of the channel, deposition is creating a growing "point bar" or what we might call a gravel bar. Where on the left side, erosion is creating an expanding "cut bank." These together are a natural process in the aging of a river, creating new flood plains and channels. However, when things are out of balance the results can be excessive erosion along the cut bank in order to dissipate the energy from floods. This imbalance can be the result of several factors including natural ones, such as the severity of a flood due to rain event, and land management practices along the river and in the uplands.

Now let's compare vegetation in both photos or in other words let's look at the health of the riparian area in both photos. Both the "point bar" and the cut bank side have much more vegetation in the 2021 photo compared to the 2001 photo. Both banks now have a good stand of Baccharis willow and immature Sycamore trees, along with other desirable plants, and the cut bank is less vertical and has more of a slope. From my observation the amount of vegetation was about the same just over 2 years ago and before the devastating October 2018 flood occurred. This probably helped dissipate the energy from the flood in this area. So, this riparian area in 2021 with increase vegetation could be considered more functioning and healthier than the same riparian area in 2001.

The other change in vegetation one can see is that of the understory of the trees. Note how open and clear it looks under the trees in the 2001 photo compared to the 2021 photo. Most of the understory you're seeing in the 2021 photo is Honey mesquite and immature cedar. Over the past 20 years due to heavy browsing by both overpopulated whitetail deer and especially Axis deer, there is practically no regeneration of the more desirable pecans, oaks, etc. TPWD is beginning to address this by protecting both existing immature and newly planted desirable woody species, as well as holding public hunts for both species of deer and hogs. This is part of a larger natural resource plan for the park, which will also include prescribed fires overtime. Otherwise up and

Beyond the changing morphology and vegetation in the two photos another visual difference is the flow or the amount of water coming down the river. The 2021 depicts a much smaller shallower channel with less water. This visual observation might be considered subjective, but when one

looks at the USGS recorded flows of the river over time it can be found that the normal or average flow is roughly half of what it was around 2001.
